Subject: August 29, 2017 Compliance Evaluation Inspection

**CWA COMPLIANCE EVALUATION INSPECTION REPORT
U.S. ENVIRONMENTAL PROTECTION AGENCY, REGION 5**

Purpose: Compliance Evaluation Inspection

Date of Inspection: 8/29/2017

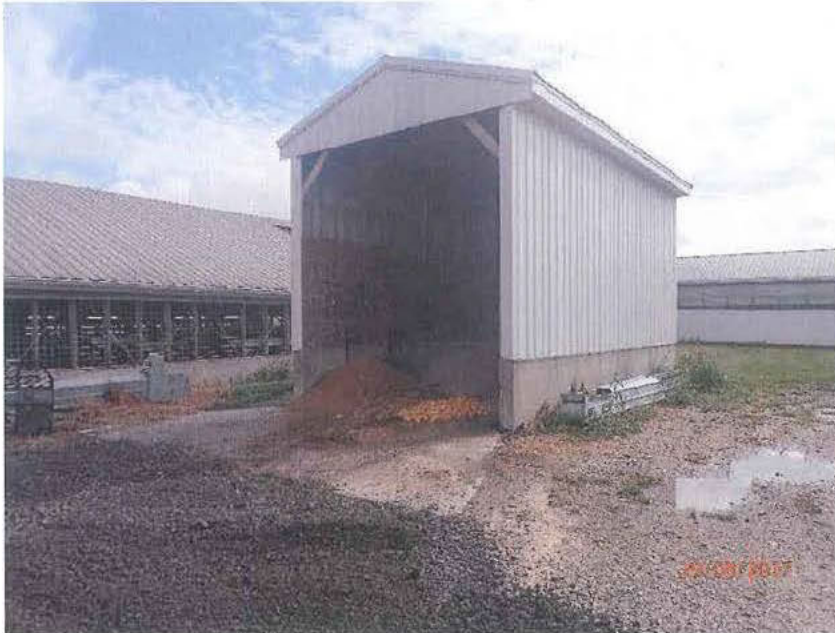
4: P8292411

Description: Wet distilled grains and bean meal in the commodity barn. Runoff flows south towards the corn field.

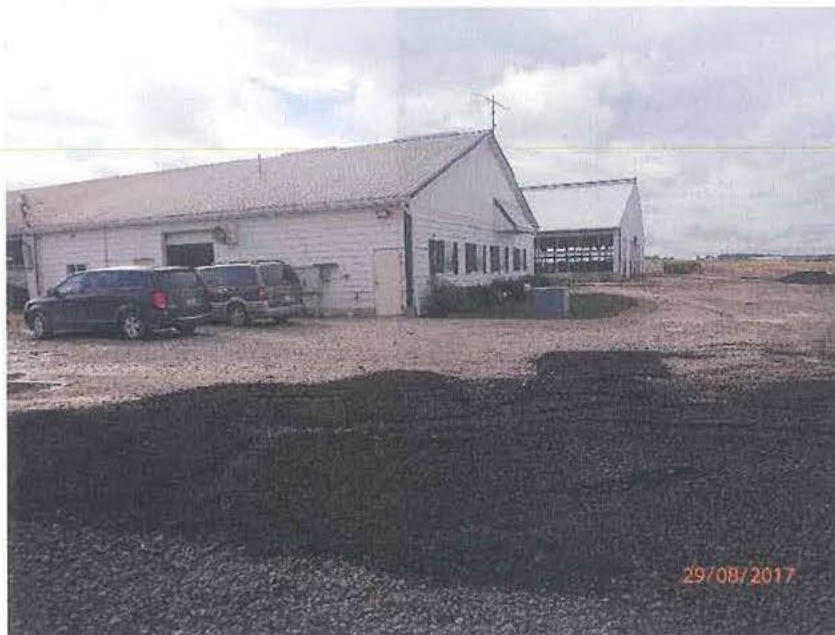
5: P8292412

Description: Area west of barns. Runoff from this area flows south towards the corn field.

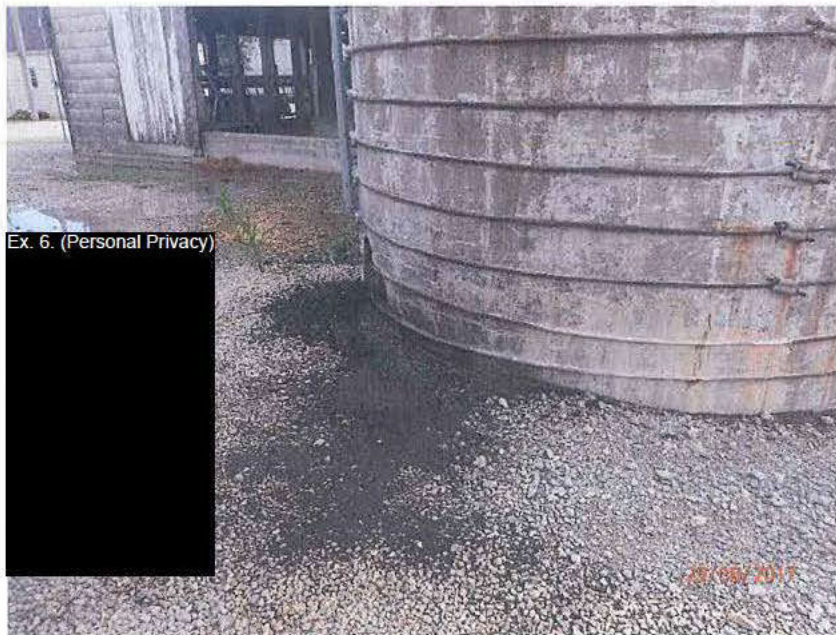
13: P8292420

Description: Old silo not in use anymore, with a hole at the bottom of it.

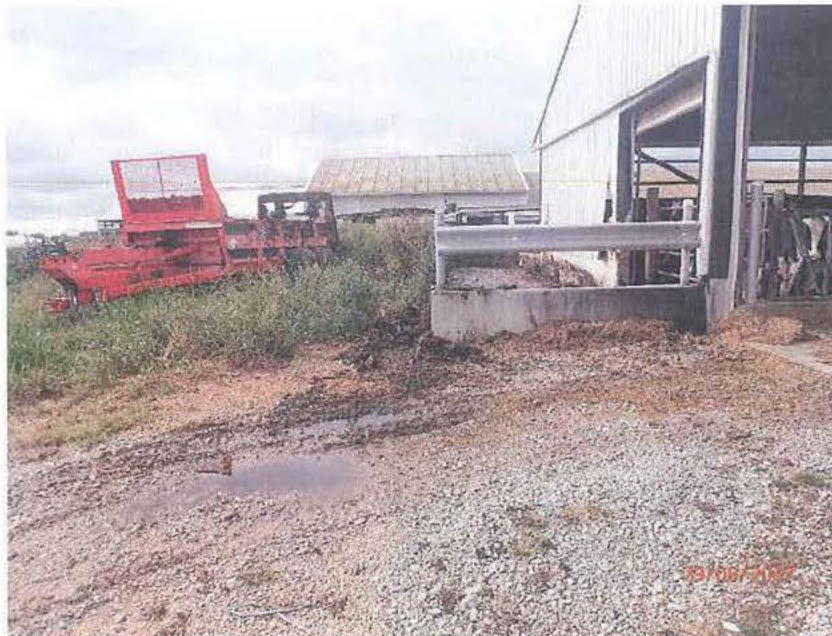
17: P8292424

Description: Pad on the east side of the Heifers barn where the scraped manure is pushed towards the lagoon.

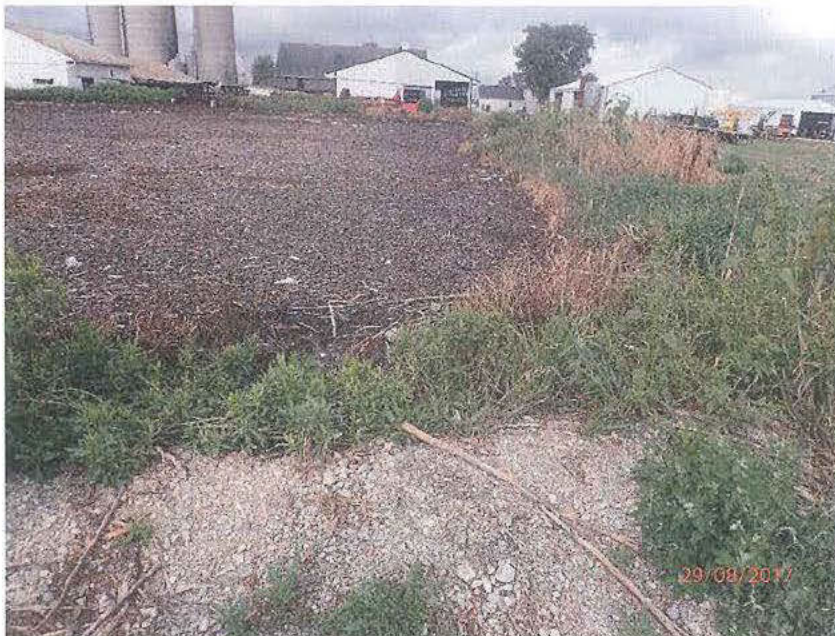
21: P8292428

Description: Very little free board at the Lagoon at the time of inspection (5-6 inches).

1. Within 30 calendar days, please provide information on how you plan to address managing the necessary free board in the Lagoon and installing a depth marker in the Lagoon.
2. Within 30 calendar days, please provide information on how you plan to address haylage and silage spills from open haylage and silage bags that have the potential to reach the drainage ditch on the east of the production area.

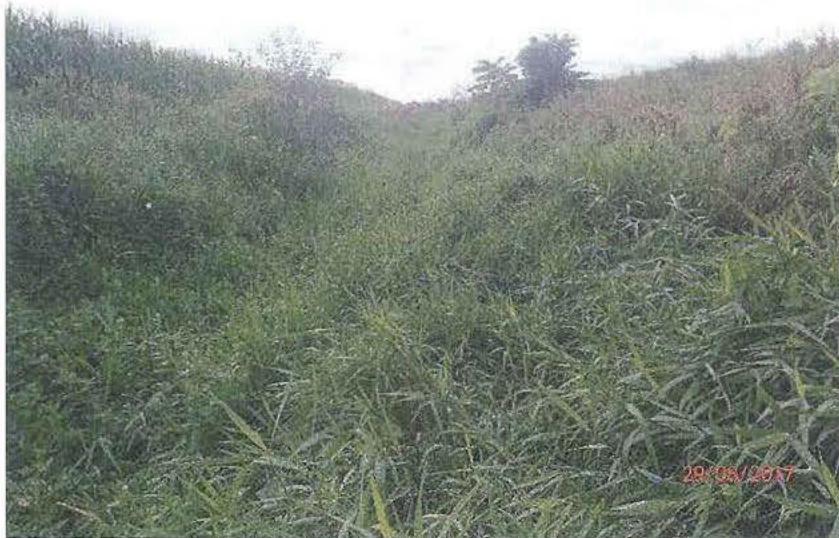
24: P8292431

EPA observed three rows of haylage bags between the lagoon and the drainage ditch (see photographs 22, 28, 40, and 41). Two of the bags were open to precipitation and process wastewater. Based on the topography, this area drains toward the ditch (see photographs 42 and 43). During the inspection, no process wastewater was flowing from the haylage bags towards the ditch. The drainage ditch was covered in vegetation at the time of the inspection and we observed a small amount of flow and a depth of water of approximately 0.5 ft in it at the time of the inspection (see photographs 23 and 24).

Description: The waterway was covered in vegetation. Water was present underneath the vegetation.

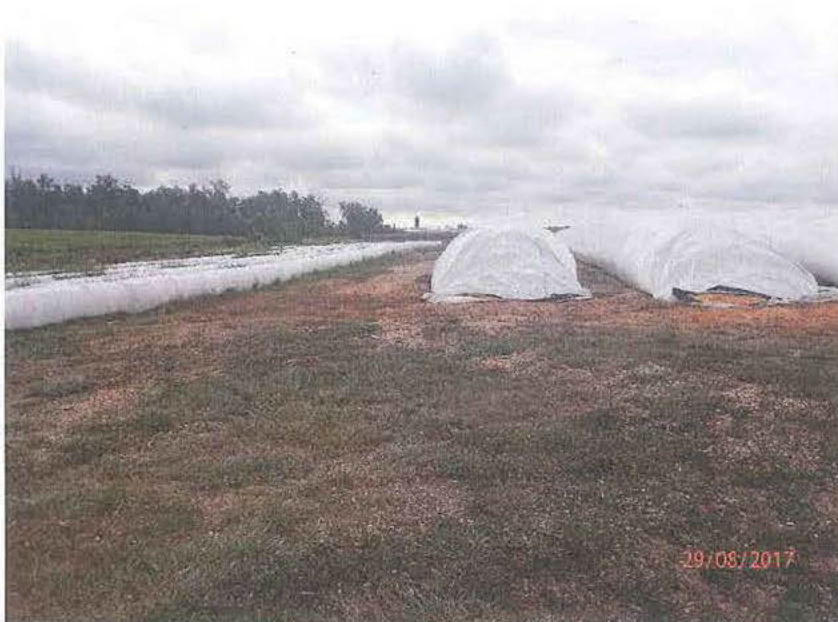
28: P8292435

Near the haylage bags and on the east side of the Dairy Cow Barn, we observed three silage bags (see photographs 27 and 28). Ex. 6. (Personal Privacy) stated these bags had recently been filled. We observed silage on the ground (see photograph 29) and browned/yellow vegetation around them. Ex. 6. (Personal Privacy) stated that the vegetation was discolored because of a gas coming out of the silage bags that would burn and discolor the vegetation around them. Based on our observations of the topography in this area, it drains towards the ditch.

Description: Recently filled bags of silage.

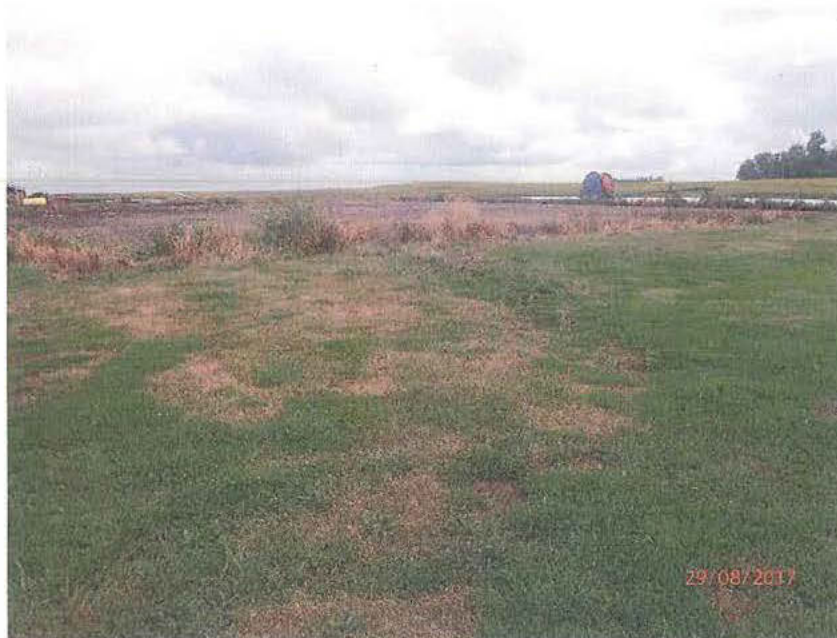
33: P8292440

Description: Grassed area in front of the Manure Press sloped towards the lagoon.

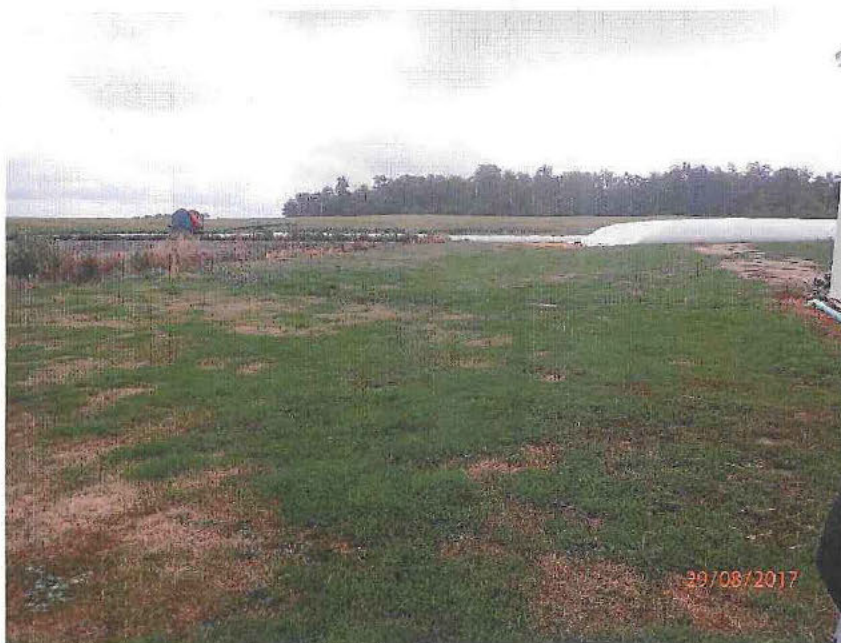
38: P8292445

Description: Grassed area east of the solids buildup sloped towards the lagoon and waterway.

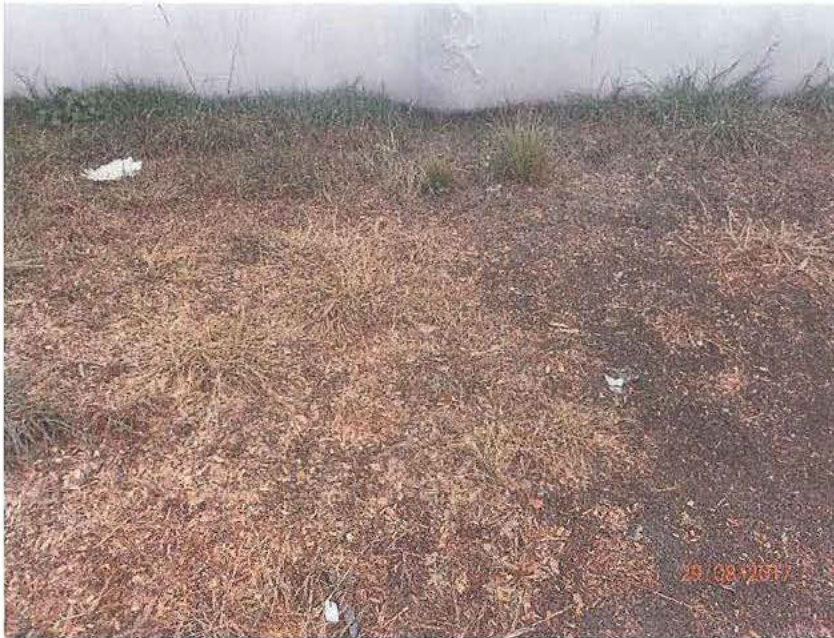
40: P8292447

Description: Haylage bag connection.

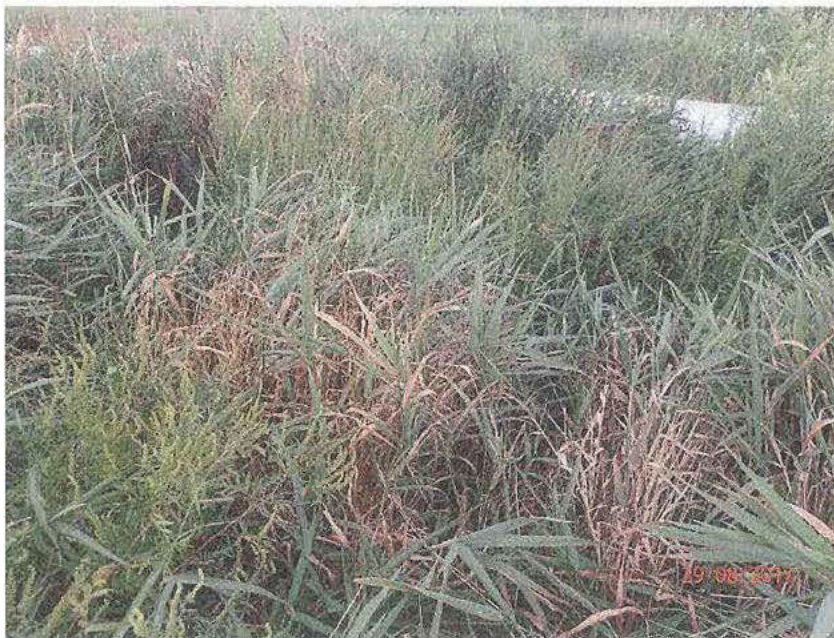
41: P8292448

Description: Grass on the east of the haylage bags between haylage bags and the waterway.

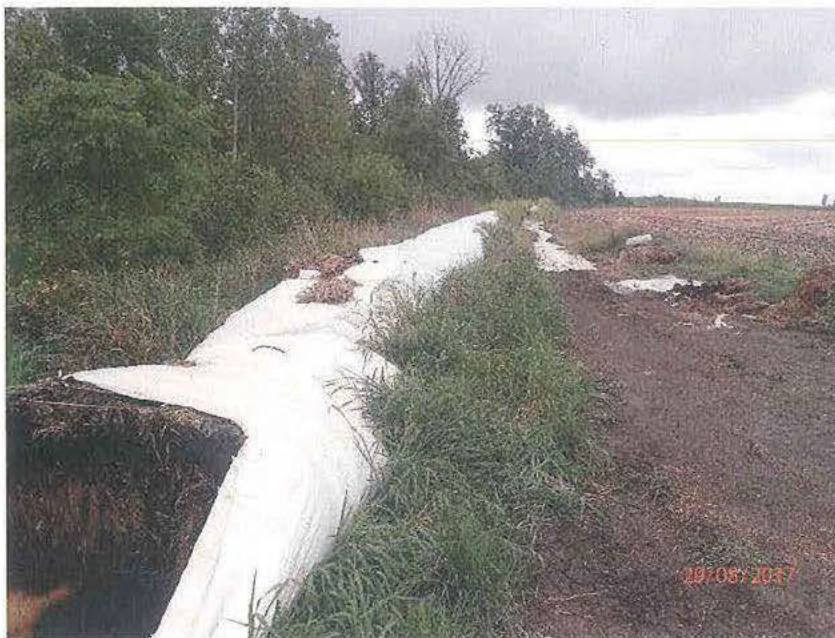
45: P8292452

Description: Wrapped wheat bags close to the waterway.

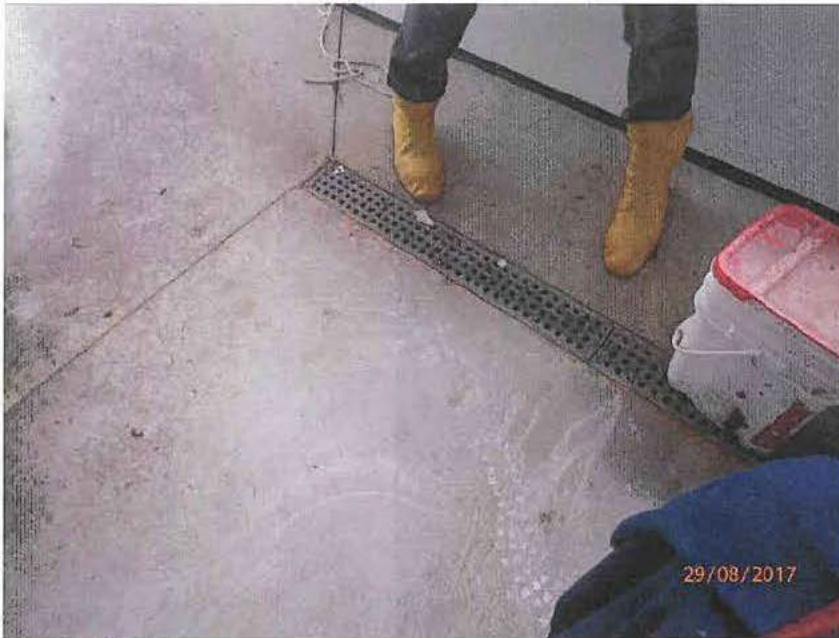
78: P8292485

Description: Floor drain in the chemical storage area. All drains go to the lagoon.

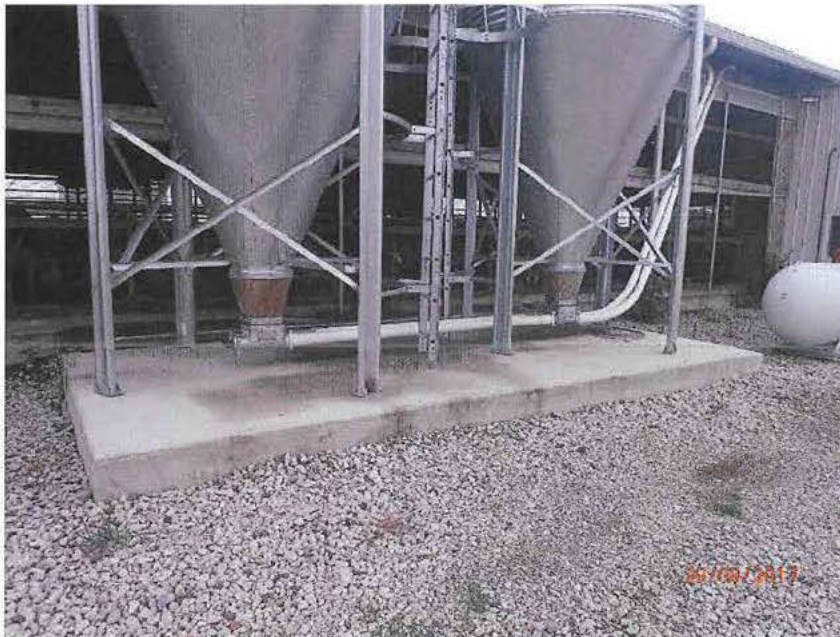
79: P8292486

Milking is performed in the Dairy Cow Barn via a robotic system (see photographs 50-76). Any manure or process wastewater from this area flows to the floor drains and ultimately to the lagoon. The chemical (teat dip pipeline acid/soap and brush cleaner) storage area is adjacent to the milking area and any spilled chemicals from this area would also flow into the floor drain and to the lagoon (see photographs 77 and 78). Outside and south of the Dairy Cow Barn, we observed two silo bins with "treats" for the milking cows which did not have spilled feed on the day of the inspection (see photographs 79 and 80).

Description: Feed bins by the Dairy Cows barn with no feed spilled around them.

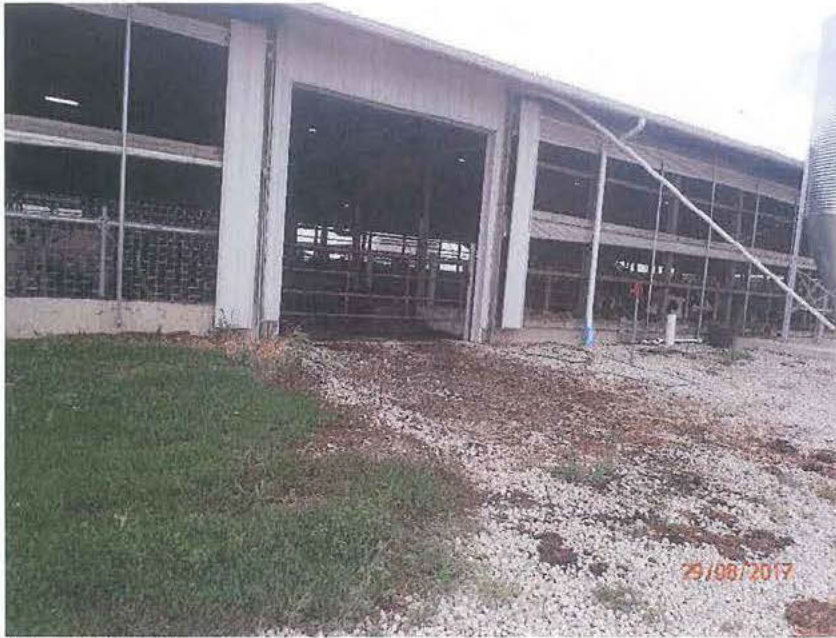
80: P8292487

Description: Runnoff from the Dairy Cows barn drains towards the lagoon.

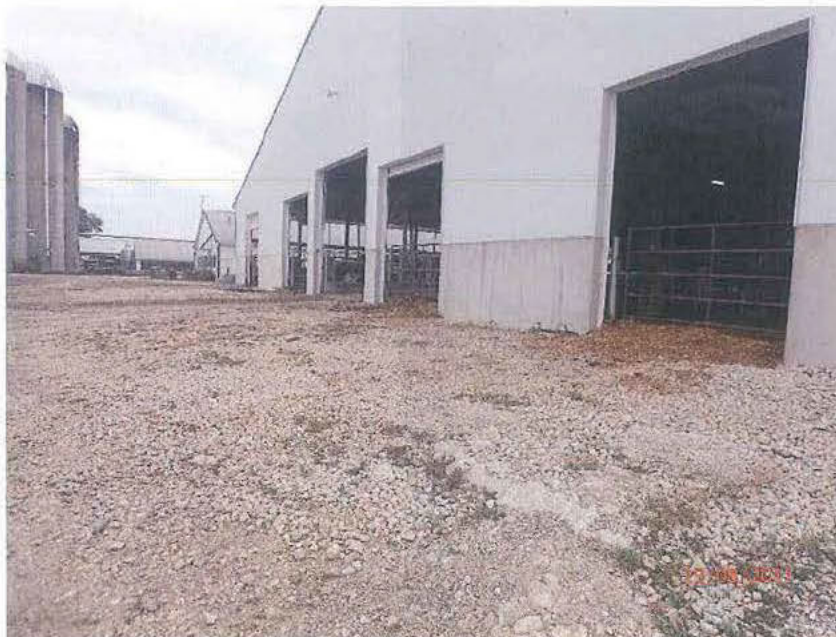
81: P8292488

Description: Runnoff from the west side of the Dairy Cows barn drains towards the corn field to the south of facility.

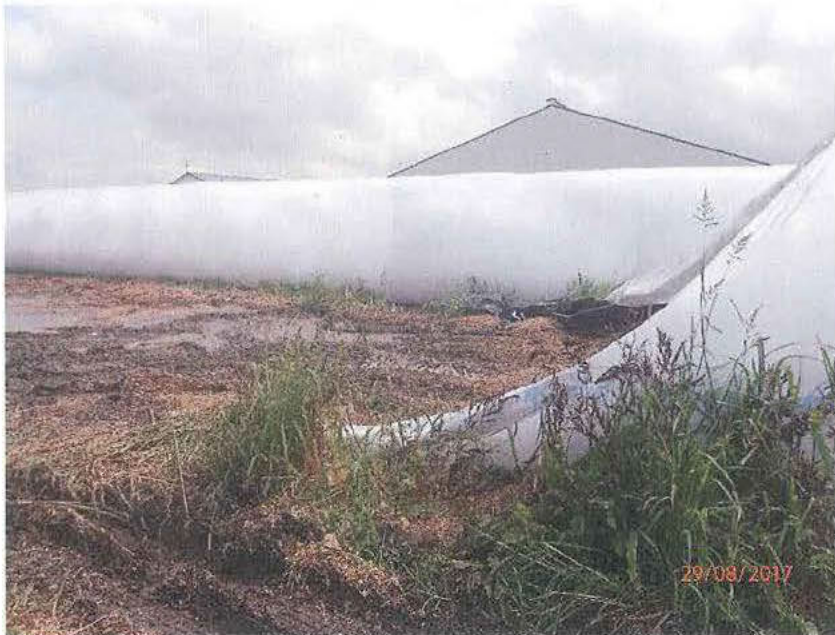
84: P8292491

Description: Open silage bag on the west side.

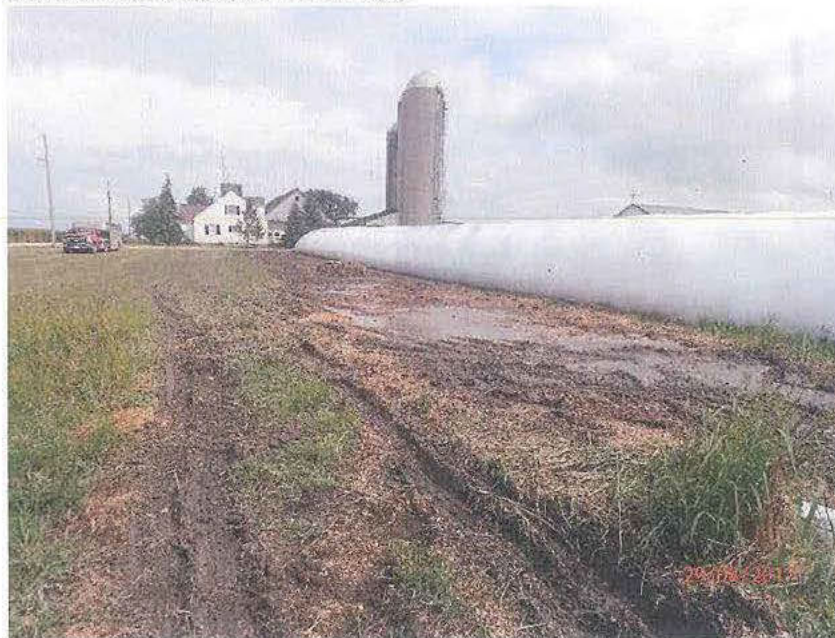
85: P8292492

Description: Pooled water between the silage bags and FOIA Ex. 6 (Personal Privacy) Road that drains towards the road.

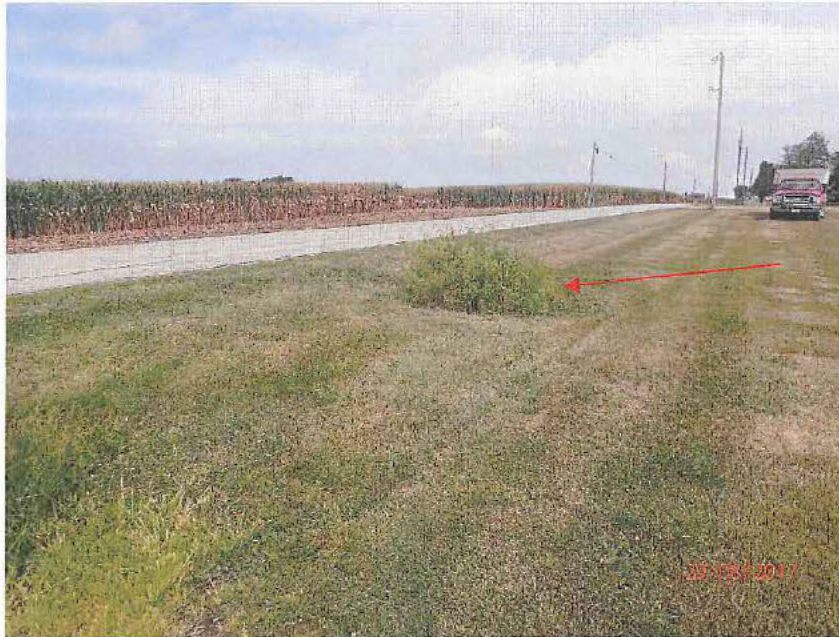
86: P8292493

Description: Drain on the side of the road that drains the area between the silage and the road.

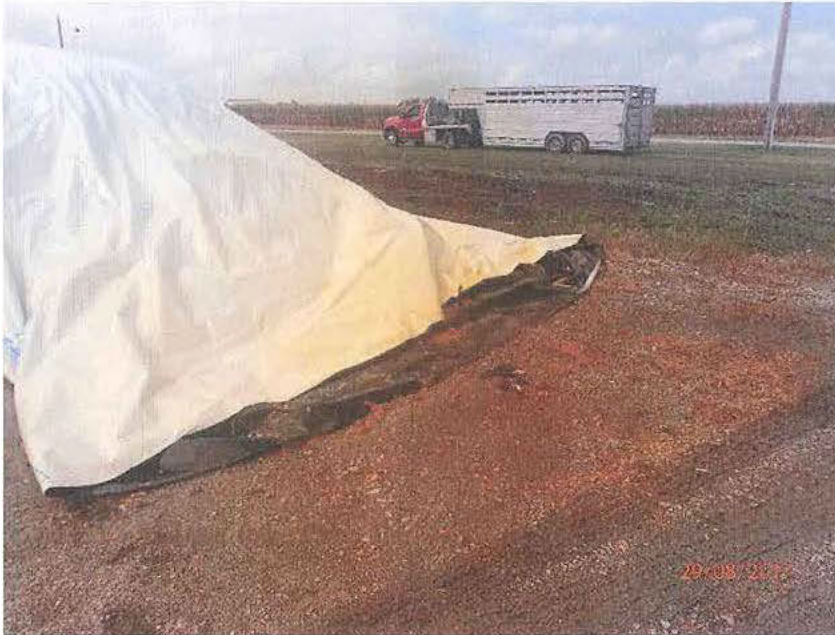
88: P8292495

At the open end of the Silage bags, we again observed some brown/yellow gas coming out of the bags and took two videos of the gas (see photographs 88-92). We then walked to the composting barn where some of the solids from the barn were open to precipitation and could generate runoff of manure or process wastewater (see photographs 93-97). The walkthrough ended at the Calves 1 Barn where the milking tanks are located (see photographs 98-100). Any spilled process wastewater from this area collects in the floor drains and ultimately drains to the lagoon.

Description: Brown nitrogen gas coming out of recently filled silage bag.

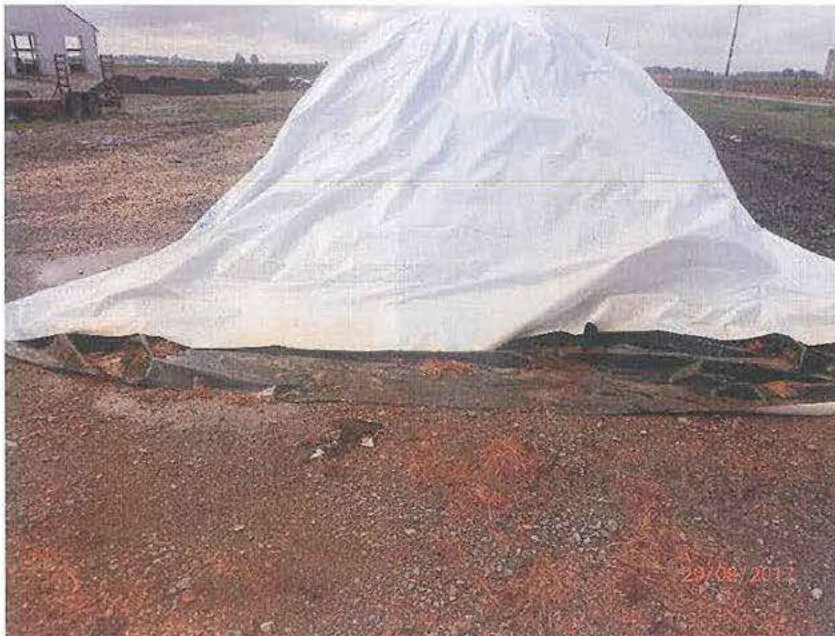
89: P8292496

Description: Brown nitrogen gas coming out of recently filled silage bag.

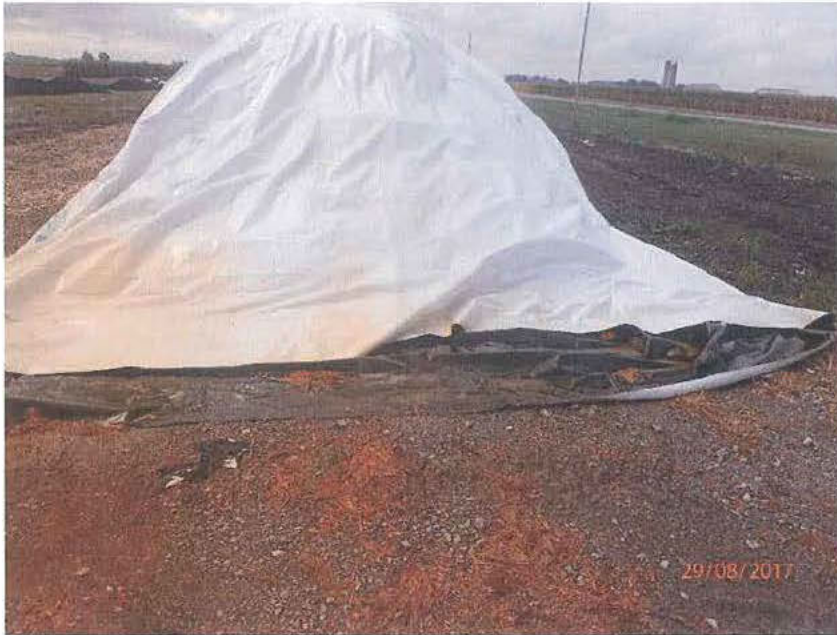
92: P8292499

Description: Brown nitrogen gas coming out of recently filled silage bag.

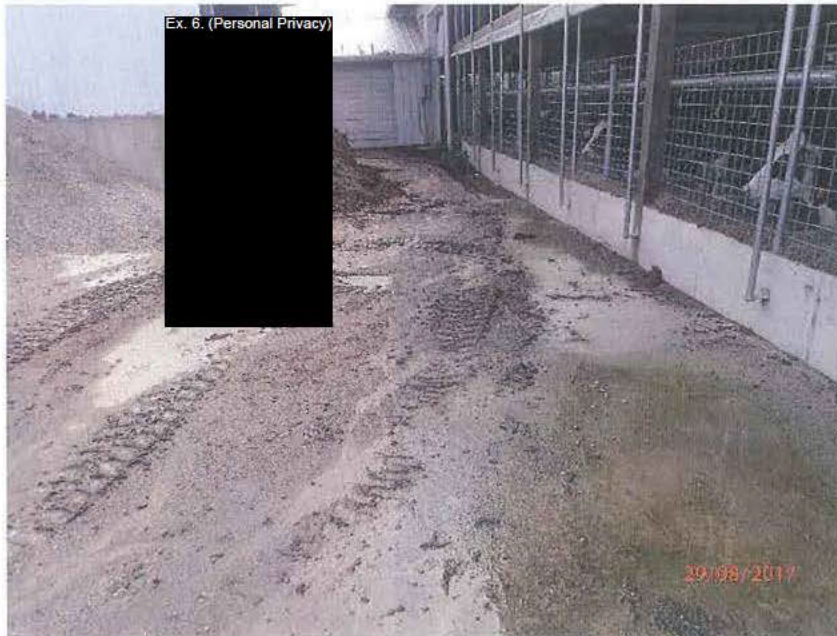
93: P8292501

Description: Solids outside of the composting barn and open to precipitation.

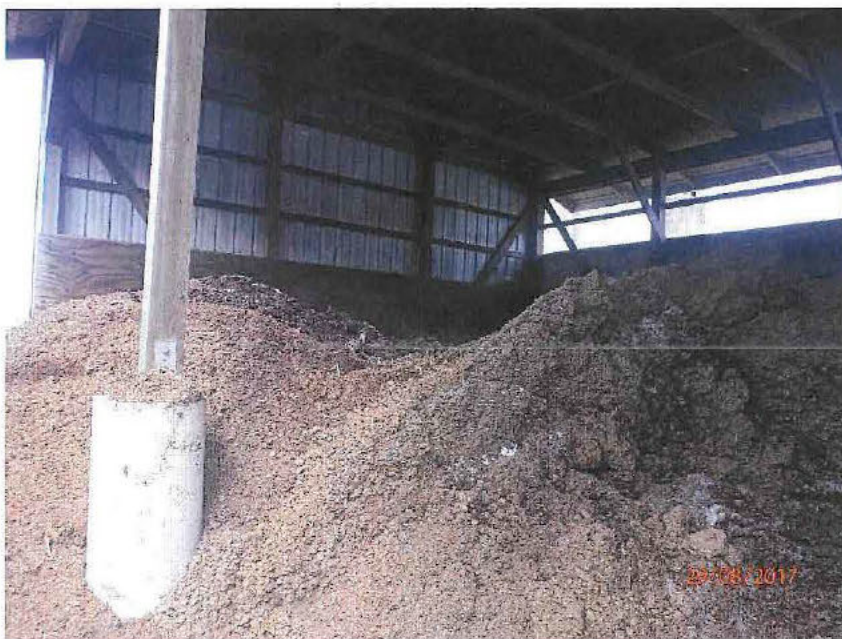
95: P8292503

Description: Compost pile. A few bones can be seen in the compost pile.

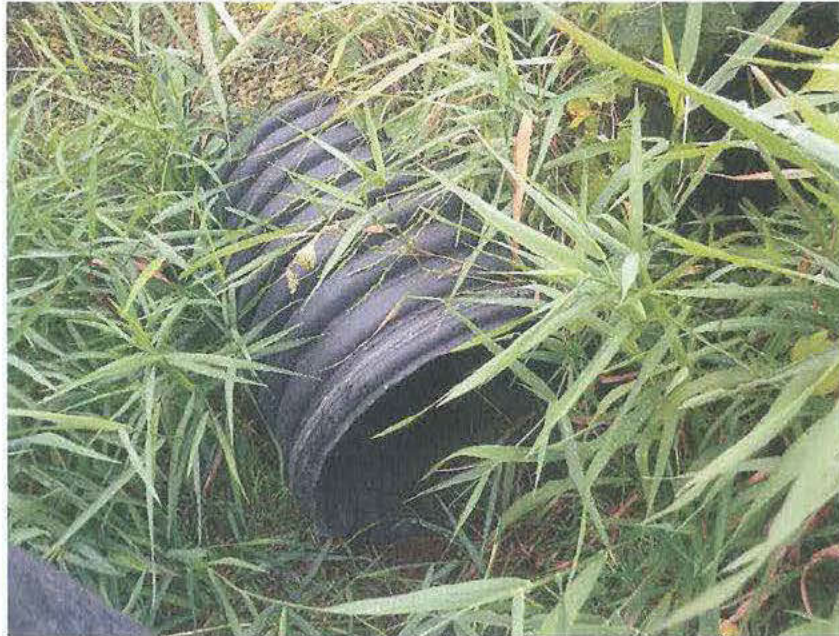
101: RIMG1902

Description: Tile drain in the waterway that drains the corn field south of the facility. Very little flow at the time of the inspection.

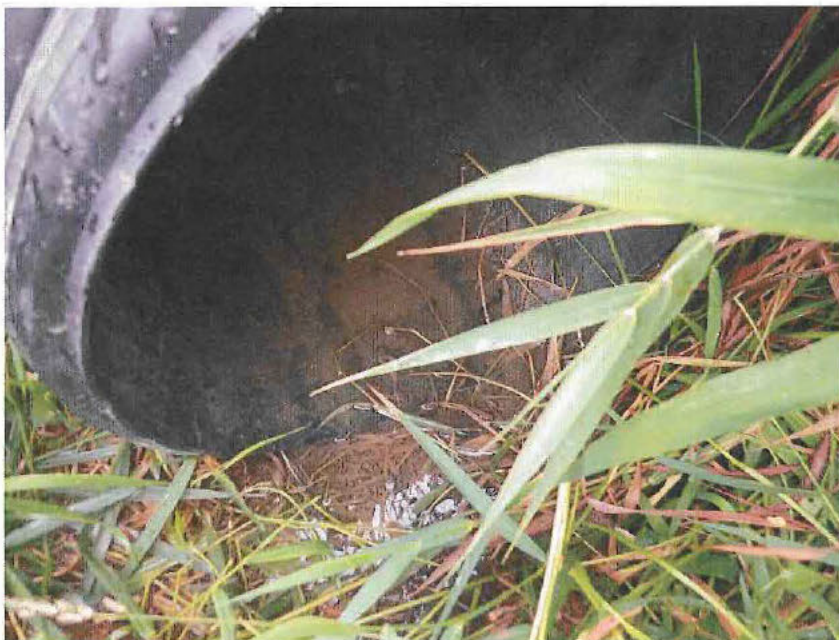
102: RIMG1903

Description: Tile drain in the waterway that drains the corn field south of the facility. Very little flow at the time.
